Vermont Granite Museum Ecological Restoration Plan

Vermont Granite Museum
and its supporting partner,
Friends of the Winooski River

By
DuBois & King, Inc.

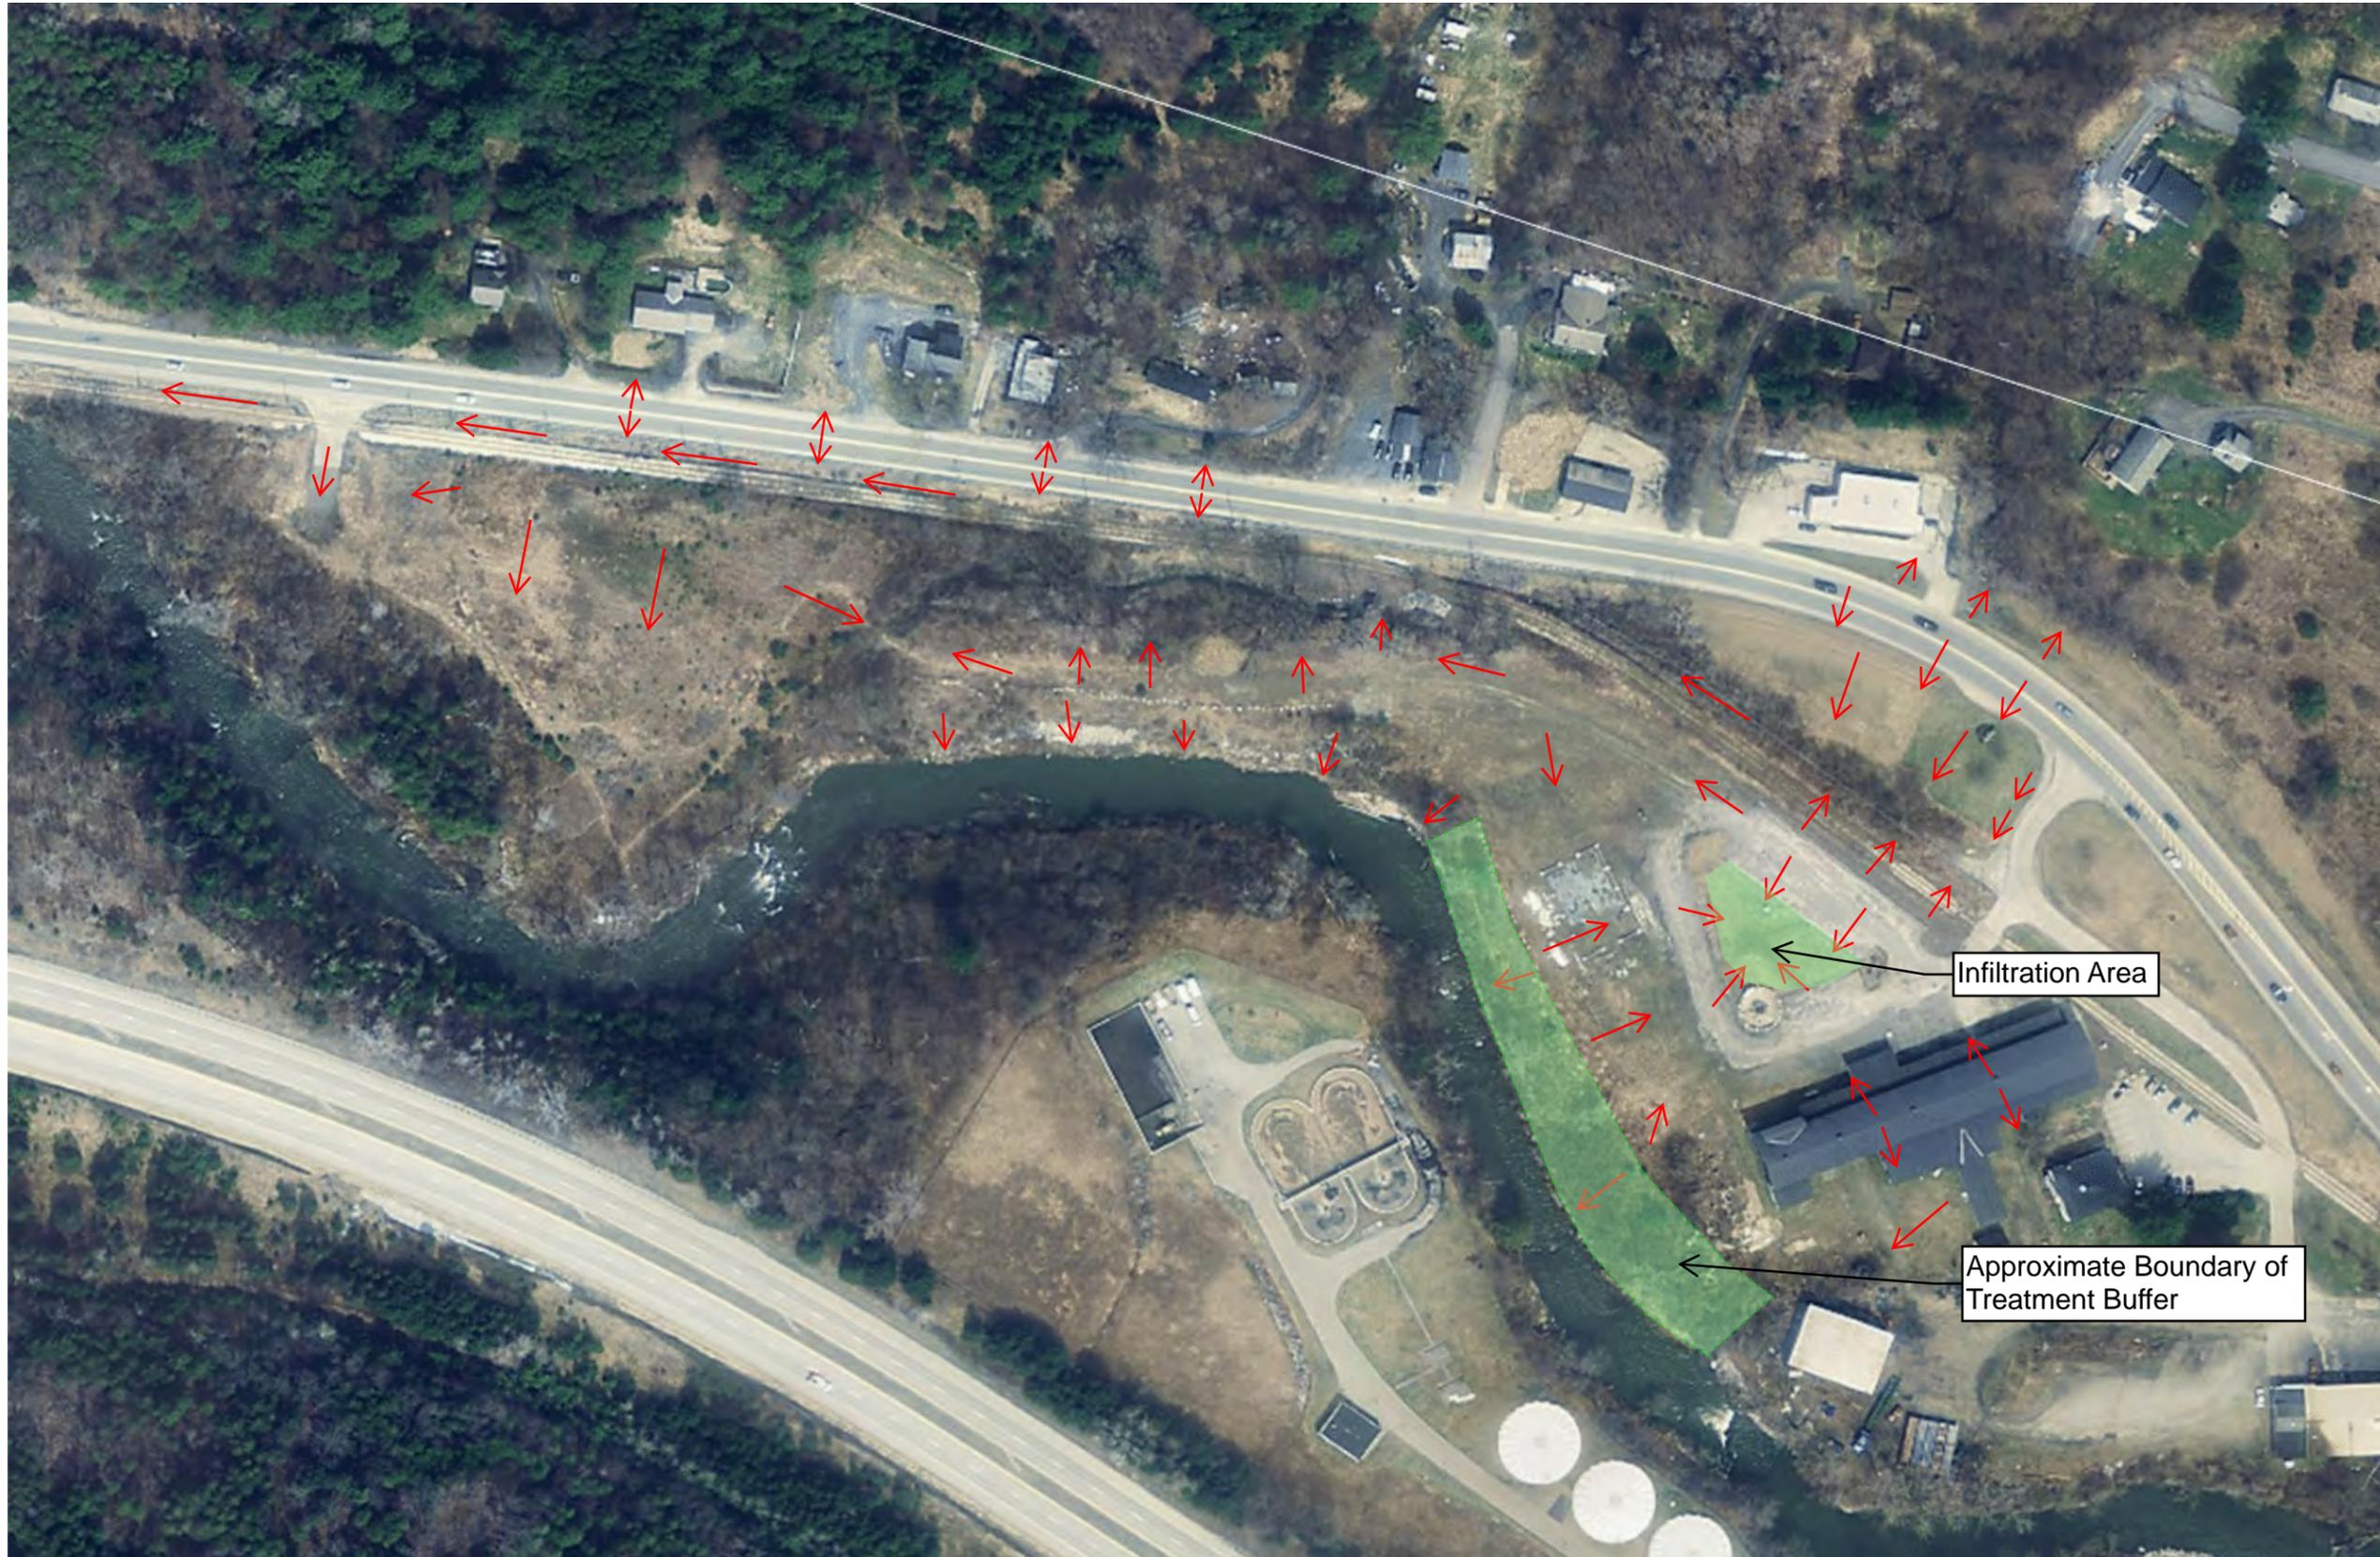
**Figure 6, Drainage and
Soils Memo**

Drainage within the site is all overland flow; there are no closed drainage systems. While the southernmost portion of the property flows south and directly into the Stevens Branch, much of the site drains back toward the north. Stormwater will either infiltrate into the ground or flow overland to the Stevens Branch or the unnamed tributary. A general schematic of overall flow patterns is attached to this memo.

The existing 3.5 acres of impervious surfaces associated with the building, access drives, and parking areas on the site are covered by a State Stormwater Permit 5594-9010, effective January 24, 2012 (copy attached). This permit identifies two discharge points, each with a different treatment mechanism. The first discharge point covers the distributed, overland flow being conveyed to the Stevens Branch, with treatment provided in the vegetated buffer to Stevens Branch. The second discharge point is located in the center of the vegetated area within the parking area, which is an infiltration area that drains into a rock dry well. These treatment areas are also depicted on the attached schematic.

The soils on the property are characterized by the NRCS as being Urban land-Udipsammets complex, occasionally flooded, as shown on the attached soils map. On-site field observations confirm this description, with additional notes of granite blocks randomly protruding from the ground as a result of the historic dumping of waste granite on the site, both in large blocks and fine material.

Stormwater drainage within the site is all overland flow; there are no closed drainage systems. While the southernmost portion of the property flows south and directly into the Stevens Branch, much of the site drains back toward the north. Stormwater will either infiltrate into the ground or flow overland to the Stevens Branch or the unnamed tributary. A general schematic of overall flow patterns is provided in Figure 6, Drainage and Soils Memo.

The existing 3.5 acres of impervious surfaces associated with the building, access drives and parking areas on the site are covered by a State Stormwater Permit 5594-9010 (see Figure 6). The Stormwater Permit identifies two discharge points, each with a different treatment mechanism. The first discharge point covers the distributed, overland flow being conveyed to the Stevens Branch, with treatment provided in the vegetated buffer to Stevens Branch. The second discharge point is located in the center of the vegetated area within the parking area, which is an infiltration area that drains into a rock dry well.

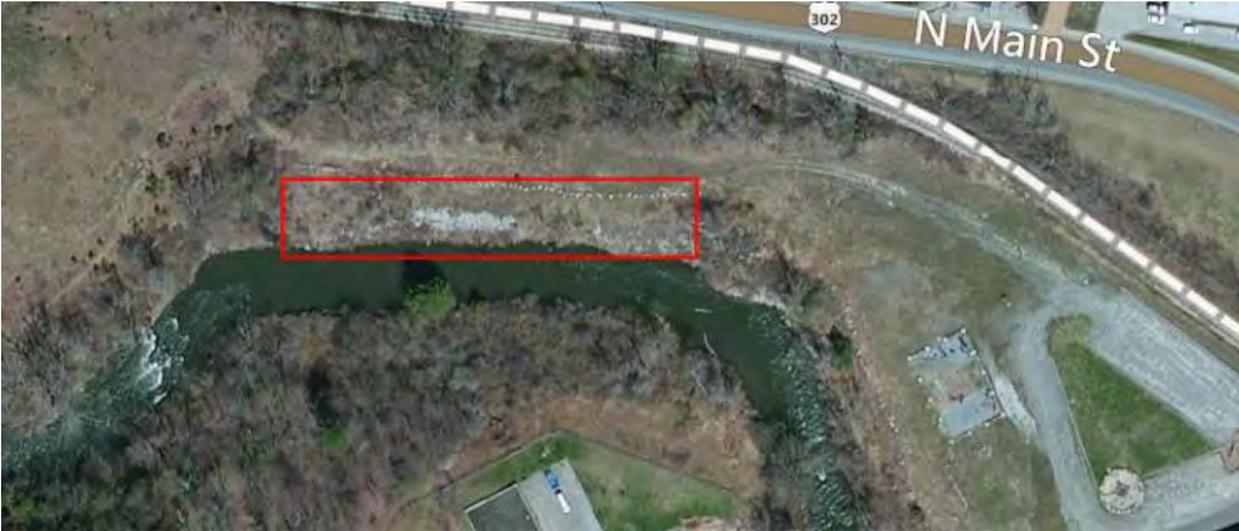
Figure 1. Previously filled area with degraded buffer

- A narrow area of roughly 300 feet of shoreline along the eastern edge of the restoration area (see Figure 10) contains highly degraded buffer, probably due to the relatively steep slope and use of stone fill. Native plant species tolerant of shallow, rocky soils should be considered for planting in this area.

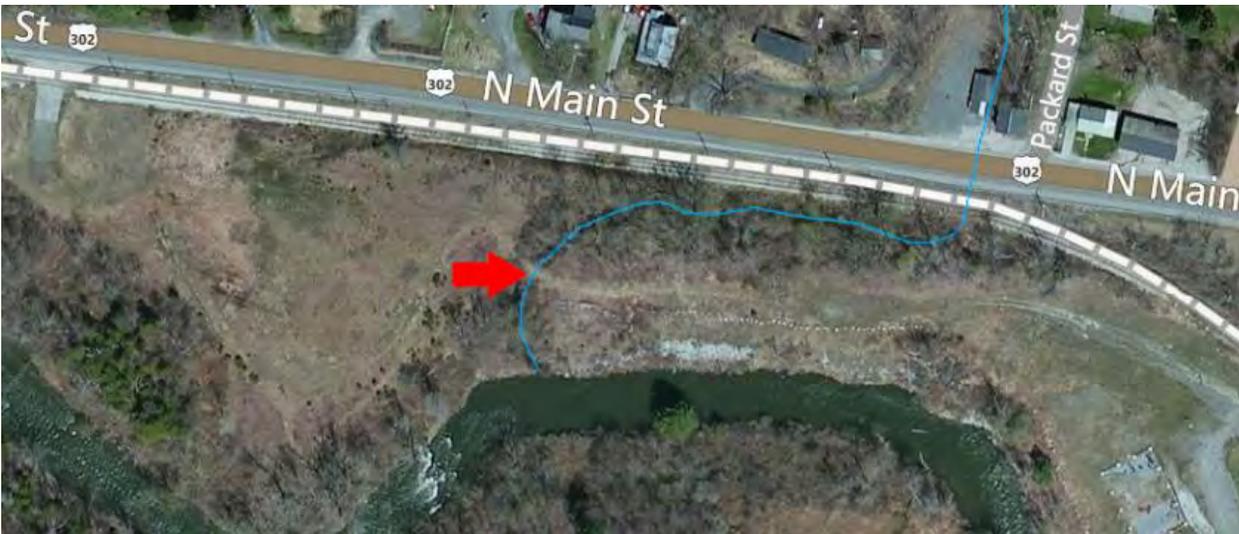
Figure 2. Unnamed tributary stream crossing

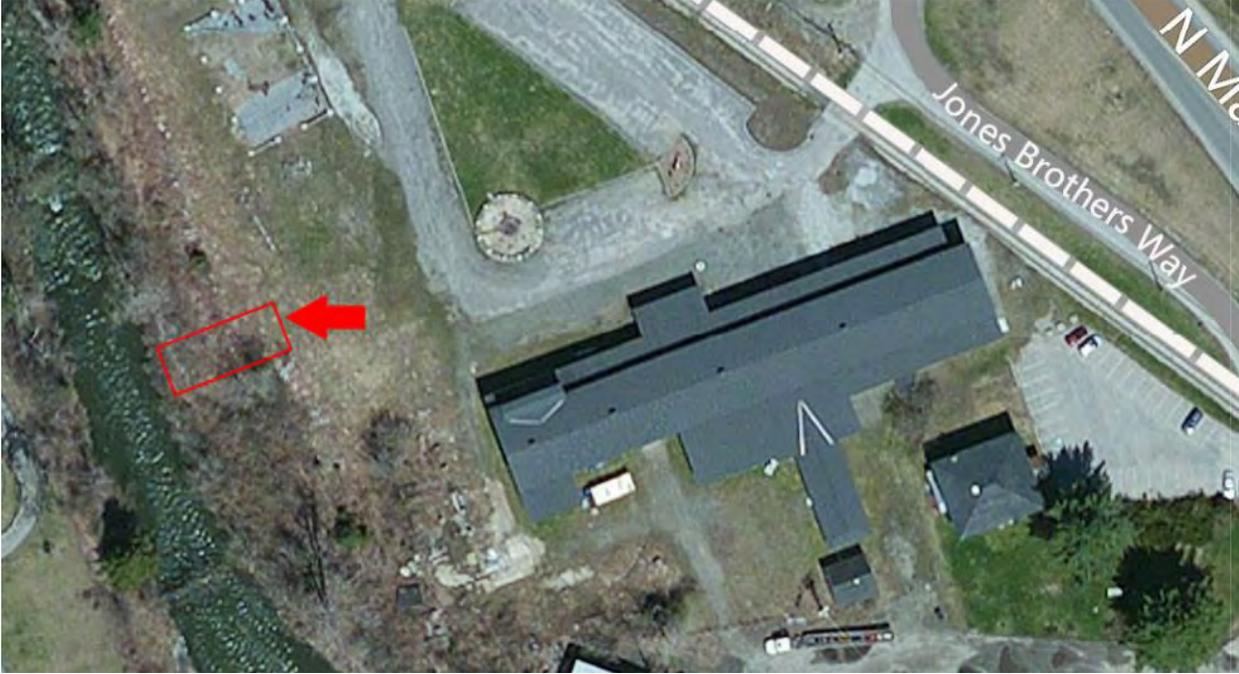
Figure 3. Proposed fire engine access

- A naturally vegetated 50 foot buffer should be maintained along the tributary banks.
- Encroachment into the riparian buffer for future fire engine access should be avoided, in accordance with the Land Use permit conditions.

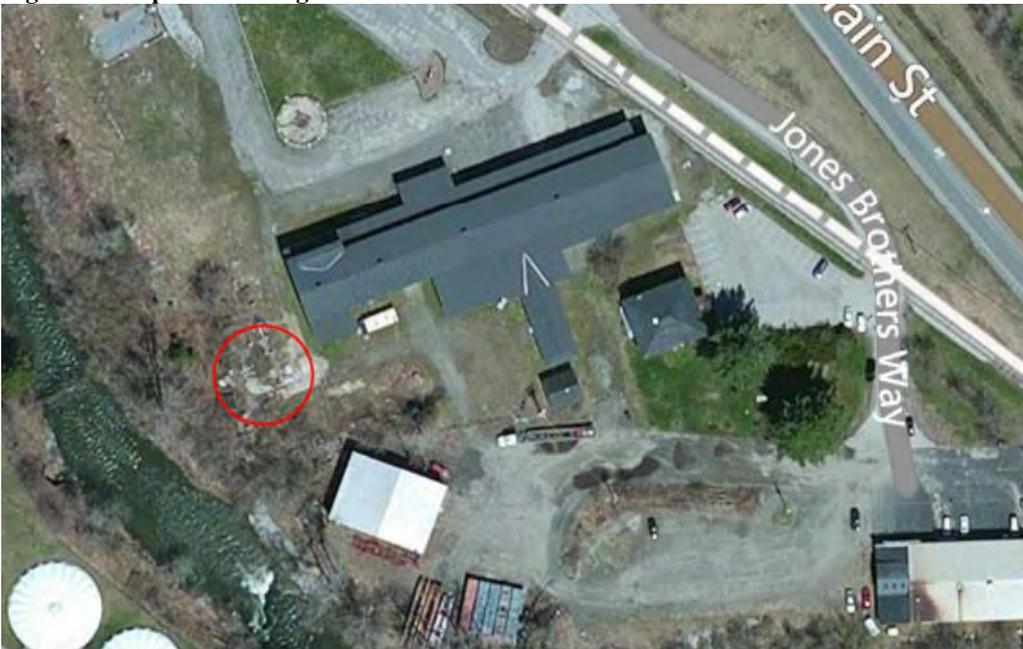
Figure 4. Area of vegetation clearing

- Additional clearing of vegetation around the old foundation near the existing museum building for interpretive purposes should be limited, and should not occur within the 50 foot riparian buffer.
